DDASaccident421

Humanitarian Demining Accident and Incident Database
AID

DDAS Accident Report

Report date: 26/07/2005	Accident number: 421
Accident time: 09:00	Accident Date: 21/09/2003
Where it occurred: Cambondo road, 2k km from Cambaixe, Malanje Province	Country: Angola
Primary cause: Victim inattention (?)	Secondary cause: Inadequate survey (?)
Class: Victim inattention	Date of main report: 21/07/2005
ID original source: JES/AVS	Name of source: JES
Organisation: Name removed	
Mine/device: TM57 AT blast	Ground condition: route (verge)
Date record created: 22/07/2005	Date last modified: 26/07/2005
No of victims: 8	No of documents: 1

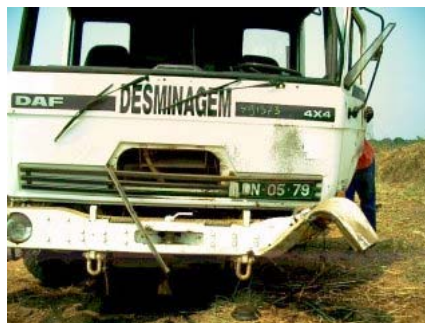
The accident happened 21 September 2003. The truck was carrying deminers to work along the cleared section of the road. At 09:00 in the morning, the truck crossed into the uncleared area by a short distance and its left side front wheel detonated a TM-57 AT mine.

The picture shows the front of the damaged truck.
